# CDF Operations Summary

Steve Hahn, CDF Meeting - November 4, 2004

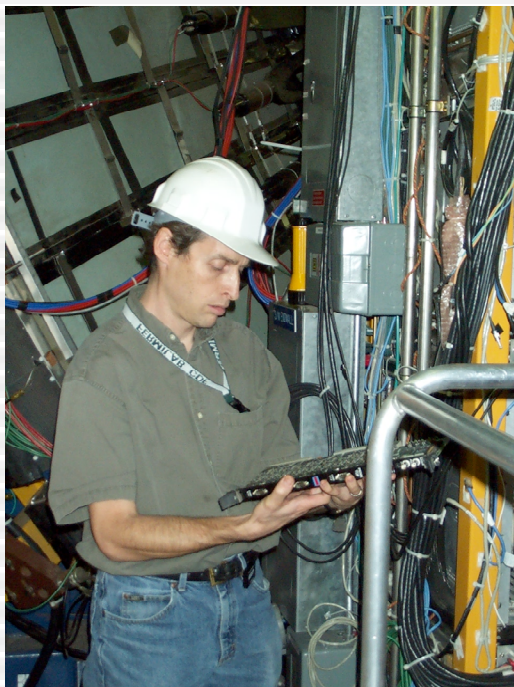
Yes, the transition cards are stained, too

- All cards cleaned
- 3 crates replaced
- Power supplies replaced
